**UNITED STATES DISTRICT COURT
FOR THE DISTRICT OF MASSACHUSETTS**

Case No.: 05 CV 10155 PBS

**PLAINTIFFS' OPPOSITION TO
DEFENDANTS' MOTION FOR
SUMMARY JUDGMENT**

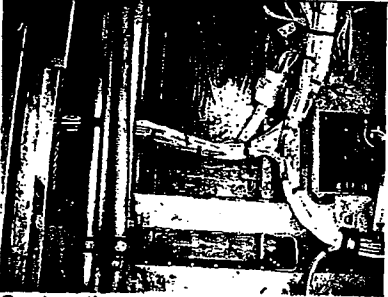
Center wing area - wet
